Geotechnical Data Report Budge Drive Landslide Jackson, Wyoming

GEOTECHNICAL DATA REPORT
BUDGE DRIVE LANDSLIDE
JACKSON, WYOMING

JULY 3, 2014

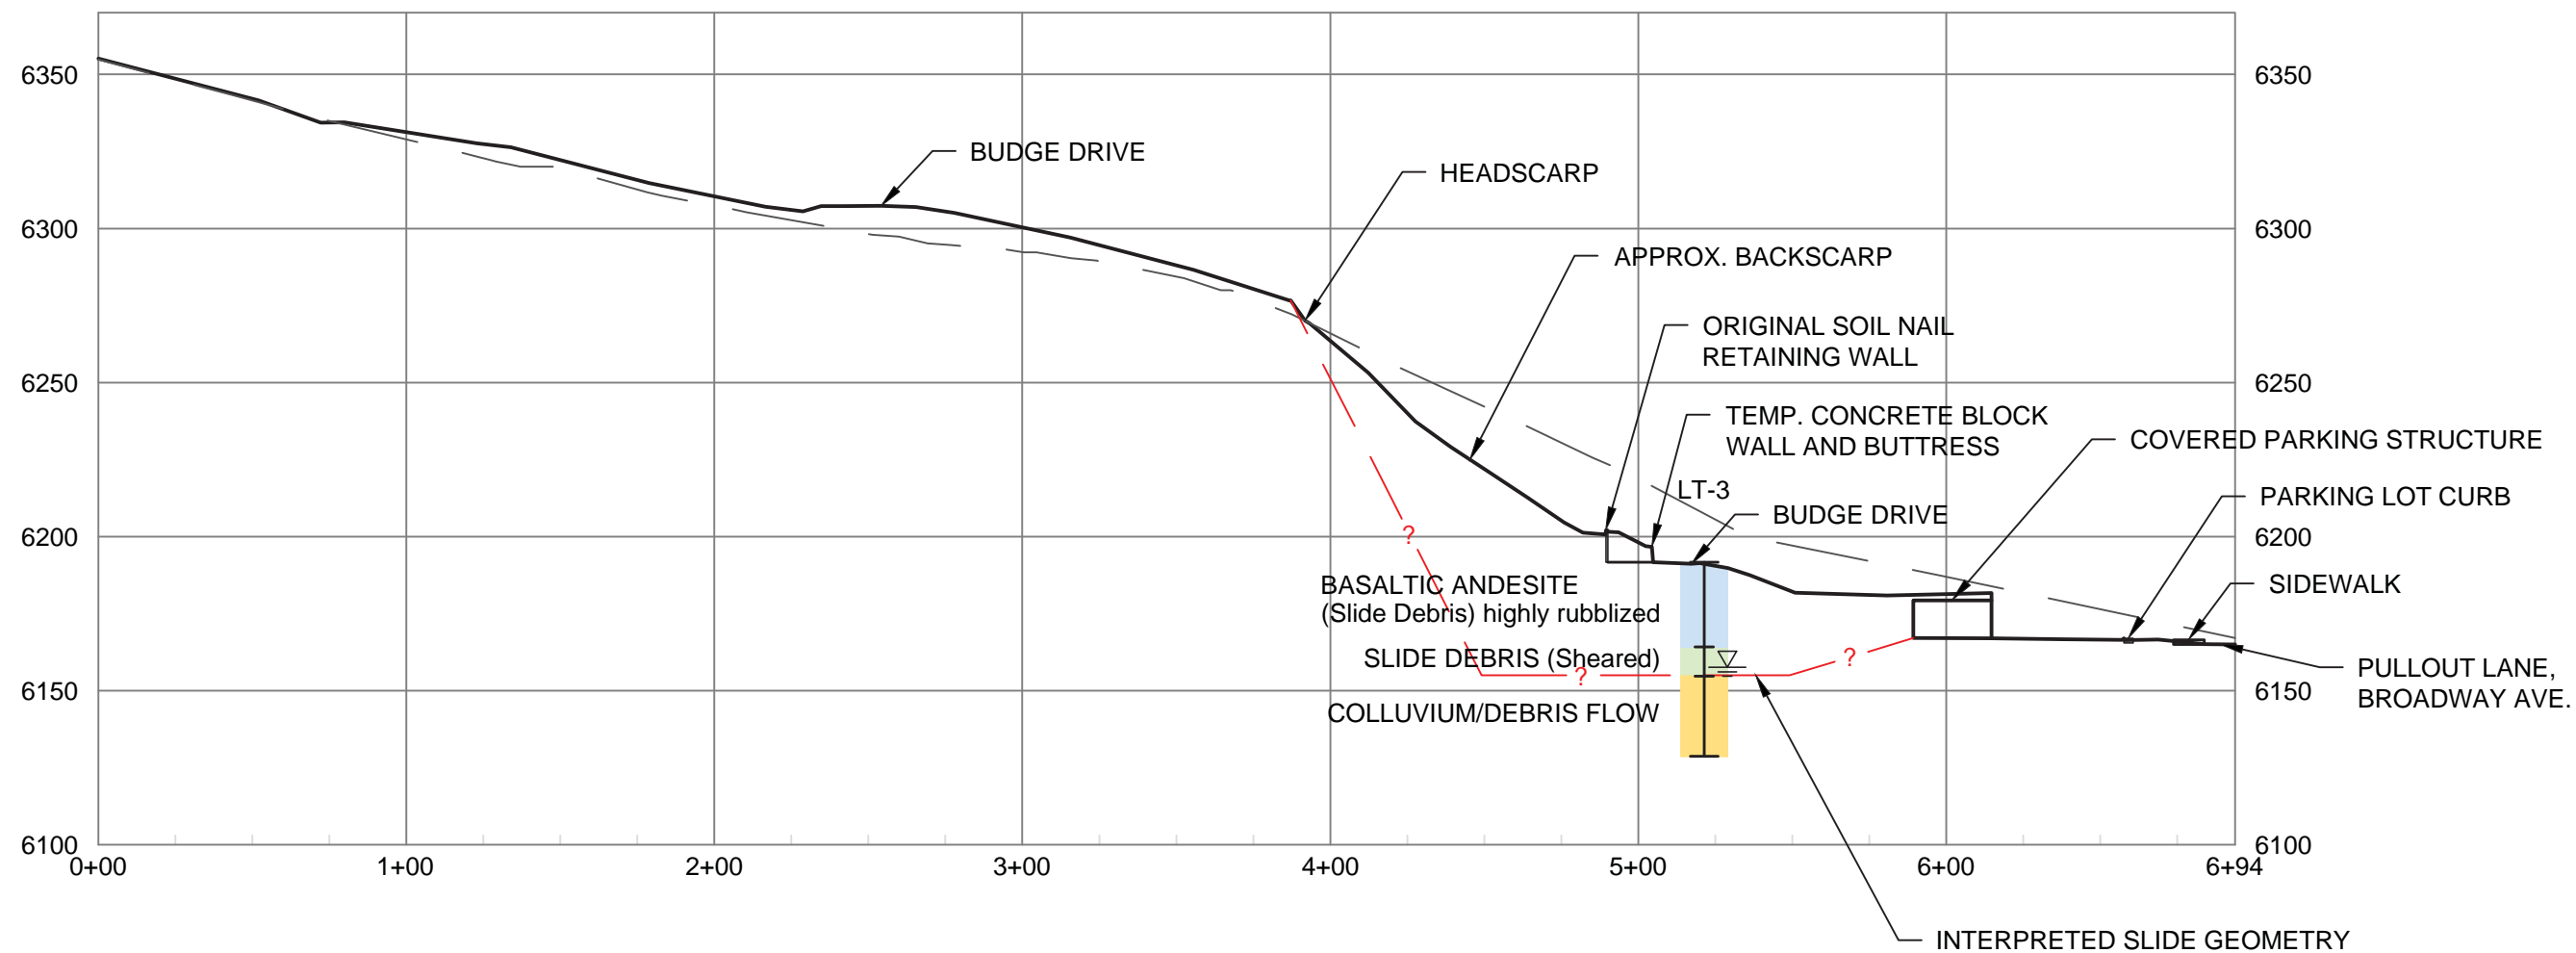
MAY 2014
PROJ. 2354
FIG. 6

Geologic units encountered at the slide site, listed from youngest to oldest, include the following: fill, colluvium, loess, landslide debris, alluvium and lacustrine deposits, weak sedimentary rocks, conglomerate, and basaltic andesite. Subsurface material conditions may be different than those exposed on the ground surface, and therefore are described in separate subsections of this report. A brief discussion of each geologic unit is given below. The subsurface conditions and landslide geometry are represented on a series of geologic cross-sections (Figures 6 through 13). The locations of the geologic cross-sections are shown on the Site Plan, Figure 3.
